Fire Investigation Report

by expert Maksim Smirnou

Analysis of Circumstances surrounding Case

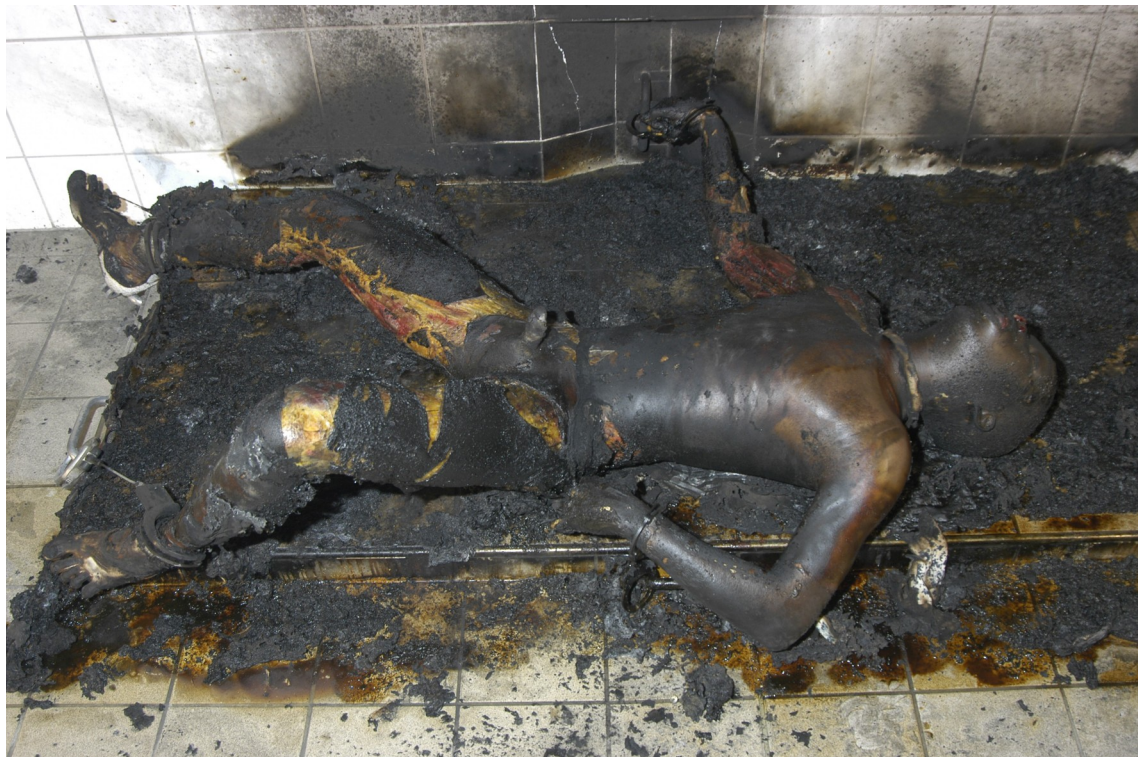
On the picture above deeply damaged skin of deceased burned to the muscles between legs and on right arm, fire amputation of three fingers of left hand. Mattress itself damaged deeply characterized to uniform temperature impact to all area. Absence of reminds not burned Polyvinylchloride “leather” of mattress including area facing floor. Absence of any reminds of Polyurethane foam in corners of the mattress, where flame front supposed to split up and would not be able to generate as high temperature as in middle of mattress and eventually burning process decays. Absence of remind of garment of deceased – presumably burned out. All above signs characterized to very flammable materials of the mattress involved in fire or high temperature impact same time involved all area of mattress, that described in literature {2, page 47} “flash over” situation, which occurs while all available fire load involved in burning process. Mattress only {2, page 35} has power (heat release rate HRR) 500-1000 kilowatts maximum. For accuracy we can calculate maximum heat release rate in our case mattress in detention room had size 1x2 meters so total area burned area is 2m². PVC “leather” at fire is charring and prevent spreading fire, hence calculations made for polyurethane foam only. According {7,8}, polyurethane foam has burning speed 0,0042 kg - 0,015 kg/(m² x sec) - from each meter square of burning area every second its burning out that weight of polyurethane foam. Full mattress from its area 2 m² in detention room loosing 0,0084-0.03 kg every second. Burning polyurethane is emitting 24,3x10⁶ joules per one kg. Maximum Heat release rate we can get multiplying

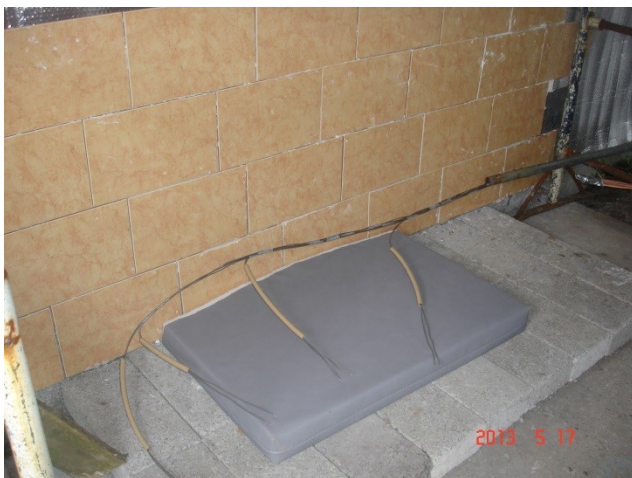
Quarter mattress test 18/05/2013.

Ignition in two spots beside tiled wall. Door closed 1 min after ignition and reopened 6 min after.

CO concentration excided in 2 minutes dangerous (A1=600 ppm) in 3 minutes was at maximum 995 ppm. CO₂ and HCl (mlast easured 4 meters from mattress) crossed A1 limit in 3 min, HCN below A1 limit with about 6 ppm in 3 min. Complete burned out part of mattress in the middle with reminds of PVC on perimeter of the sample, not burned Polyurethane foam in remote of the wall corners.

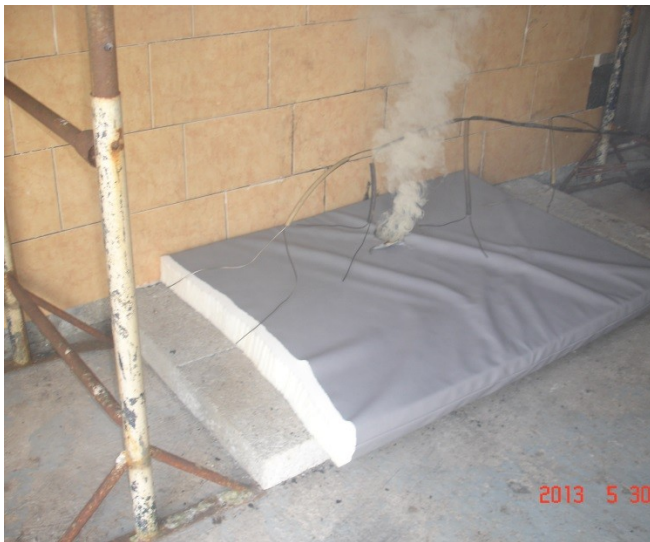
P1. Moment of setting fire

Cuts made on PVC cover of mattress in middle of sample 20 centimeters to wall, fire set up by lighter in one point. Door was

closed after one minute imitating smoke alarm turned off cell ventilation system in detention room in Dessau. After 6 minutes door was opened imitating discovering fire by policeman. It has revealed that fire after spreading deep in mattress foam and to all directions has extinguished itself. PVC cover is burning hard and projecting about 0.7 to 1.5 centimeters over ellipsoid shape area of foam 21x11 x9cm burned out to the PVC cover on other side. Total volume of foam burned out is around 0,0025 meters cubic (2.5 liters).

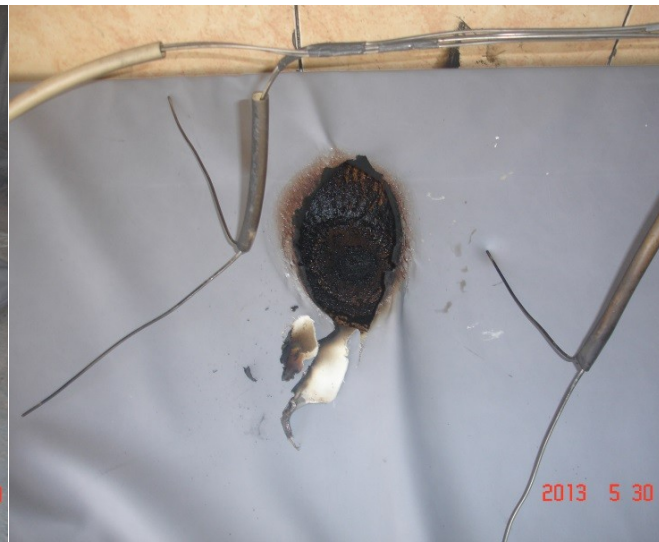
P2. Burning area

With relatively small area burned out (not exceeding 1,5% full area of mattress) concentration of CO₂ in air was over 4 folds higher than dangerous for health (limit A2 recommended by Draeger), NH₃ over dangerous (limit A1), concentration O₂ fall dawn to about 16% (well below A1). Maximum of HCN concentration was 0.8 particles per million 12 folds less than A1 limit. Temperature same time was not over 30°C in one point of “Right Shoulder”. Other thermocouples produced lower result.

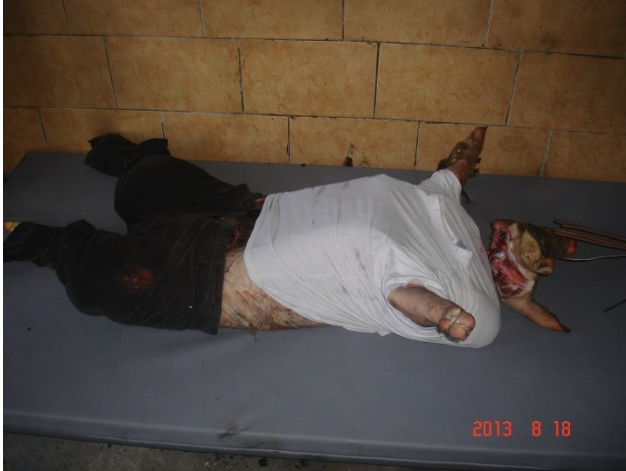
P1. Pig's body before test

Full mattress test with pig's body putting 200 ml ethanol spirit 18/08/2013 13.30 Pig's body wrapped in jeans and T-shirt placed on mattress. Cuts made on PVC cover of mattress between the wall and pig's body and on pig's other side. 100 ml of ethanol spilled on right side of pig's body and 100 ml spilled on left side. Fire set up by lighter in both parts. Door was closed after one minute and opened after 25 min. On the pictures below you can see, that the development of fire stopped on both sides of pig's body at places contacting mattress with upper and lower paws. In one minute after ignition CO₂ level overcome A2 dangerous concentration and reached 1.08%; CO and NO nearly reached A2 concentration 1080 ppm and 40.6 ppm. "Walk in" 25 min after fire started revealed dangerous concentrations of HCN and Phosgen CCl₂O.

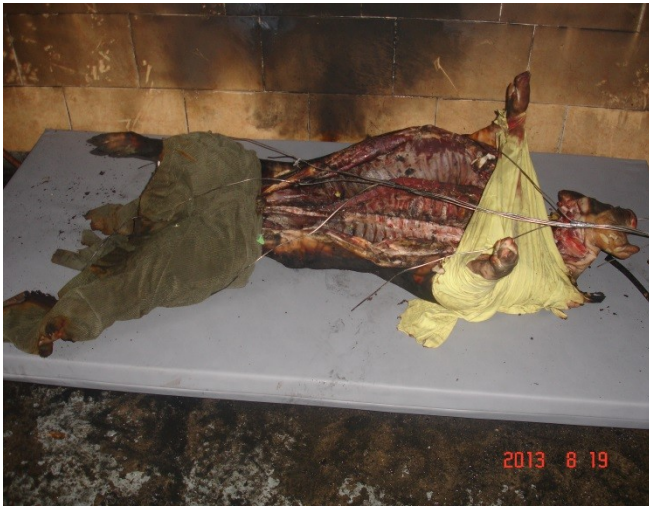
P.1 View before test

Full mattress test with pig's body putting 750 ml BBQ lighter liquid
19/08/2013 18.00 Pig's body wrapped in jeans and T-shirt placed on mattress. Cuts made on PVC cover of mattress between the wall and pig's body and on pig's other side, 750 ml Barbeque Lighter Liquid (kerosene), sprinkled over mattress and pig's body. Fire was set up by lighter in both parts. Door was closed after one minute and opened after 35 min. On the pictures below you can see, that the development of fire stopped on both sides of pig's body at

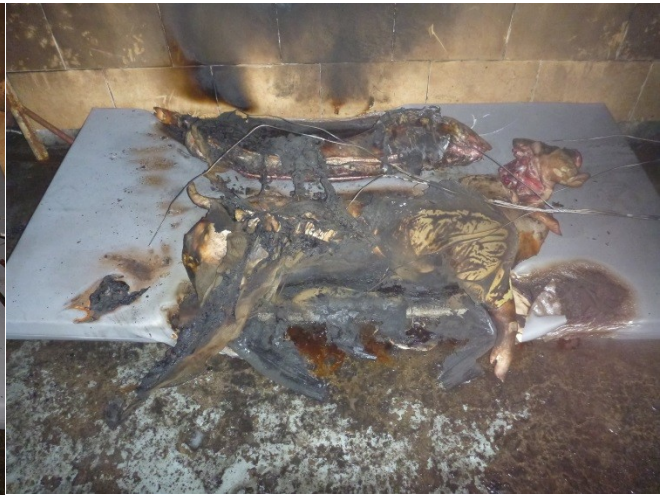
P.2 After test

places contacting mattress with upper and lower paws. In 2 minutes after ignition CO₂ level overcome A2 dangerous concentration and reached 1.46%; NO reached over A1 concentration 25.8 ppm, HCN overcome A2 limit and reached 30.9 ppm, CCl₂O overcame A2 concentration 48 folds and reached 9.6 ppm. NH₃, NO, Cl₂, CO and O₂ level have not reached A1 concentration. Temperature in area “right shoulder” and “right of head” in 2 min reached 200.2°C and 87.8 °C; in 3 min - 313.4 °C and 112.1 °C . .

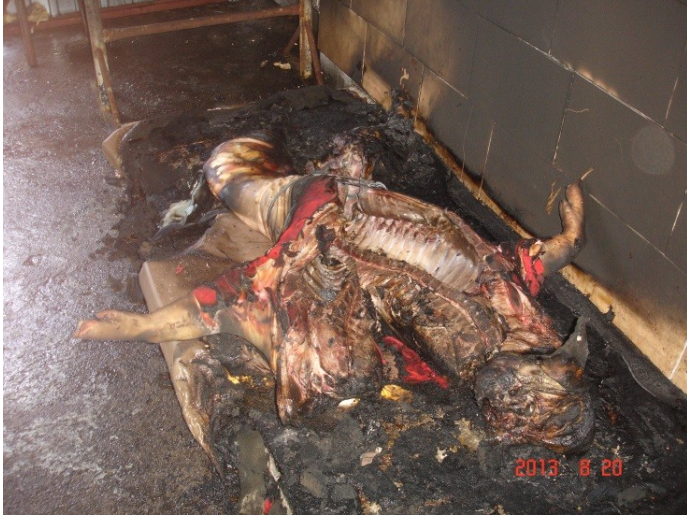
Pictures of the results of the tests are on the left side, pictures taken from Oury Jalloh death are scene on the right side.

In spite of using at tests 2 liters accelerants liquid (petrol) there is some rests of fabric materials pig's body was wrapped in before test and also some parts of mattress survived at lower limbs location and on the left side of pig's body; while there is completely burned out material of mattress occurred in cell.

3. The test using 2 liters of petrol as fire accelerant on 20.08.2013 is the most corresponding visually to the case of Oury Jalloh.
4. Concentration of CO (carbon monoxide) significantly reduced after removing upper layer of polyvinylchloride leather of the mattress and was not dangerous even while using 5 liters of petrol.

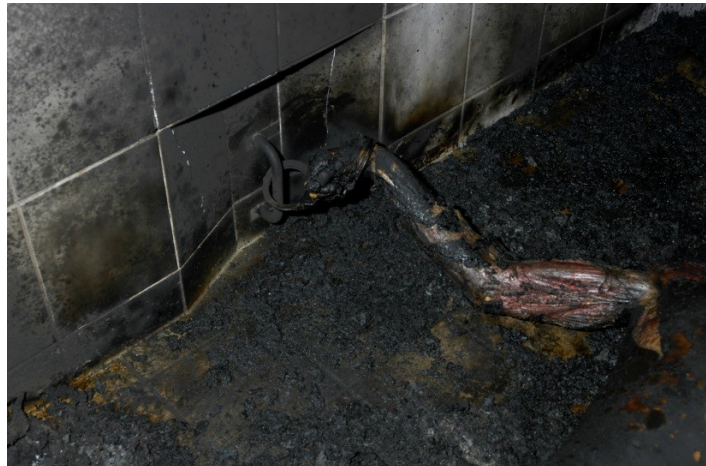
Cracked tile in middle of the wall achieved only in last test with petrol as accelerant never occurred using ethanol (spirit) or kerosene (barbeque lighter liquid) on previous tests, mattress connected to the wall in all tests, made strip of not covered by sod, there is no such strip on the wall in right picture of scene of Oury Jalloh's death, like it was possibly open space between mattress and the wall.

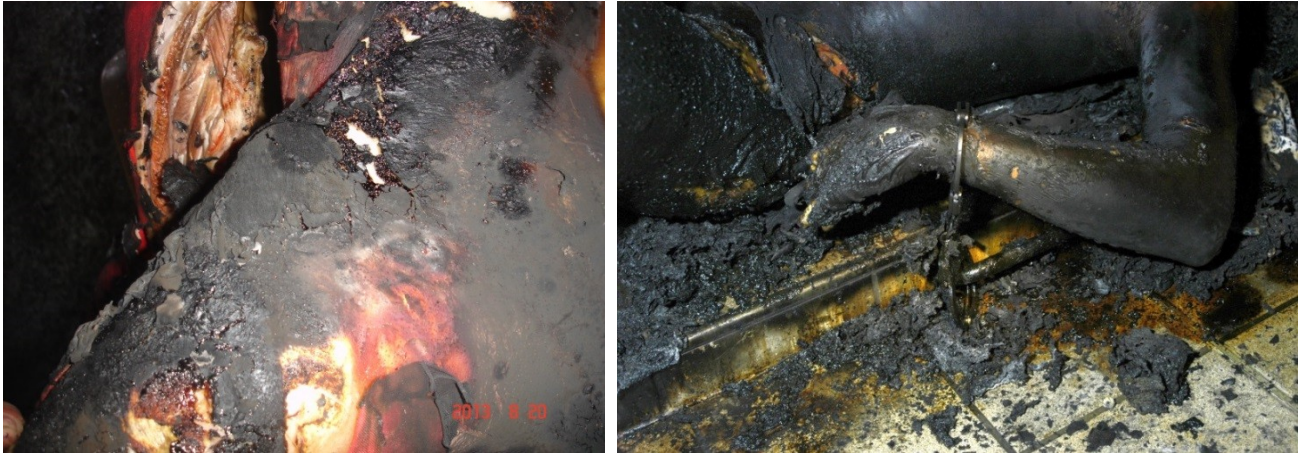
Complete deterioration of the pig's skin found in one place on the right upper paw and there are multiply deterioration spots on Oury Jalloh's body even in places with relatively small area of burned mattress like around left hand less

fingers, some places of the body like right arm skin burned out completely making visible muscles (see also pictures above).

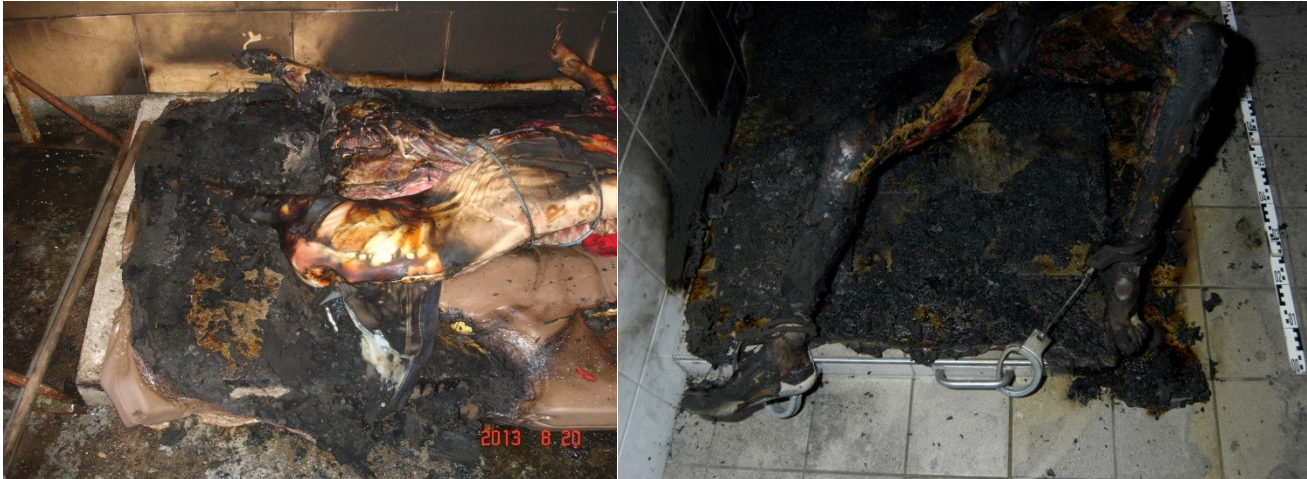
There are some areas of the tested mattress in middle burned through completely producing nearly same result as on scene of death of Oury Jalloh, but no strip around perimeter of the mattress and no corners.
